The Road Inventory of Pixley National Wildlife Refuge Tulare, CA

Prepared By: Federal Highway Administration Central Federal Lands Highway Division March 2012

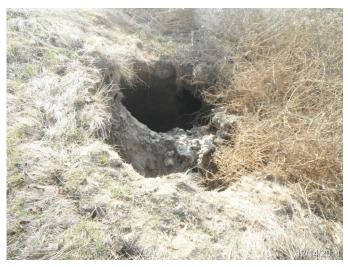
Photo: PIXL_C4_0507 Route: 402-003-2.86 Deficiency Culvert Further Investigation Required Culvert Washing out Asset# NA
